Following the earthquakes of spring 2015, EDA initiated a reconstruction program to support the villages of the Taksindu VDC located in the Solokumbu district.

COMMUNITY CENTER IN CHHULEMU, NEPAL EMERGENCY AND DEVELOPMENT ARCHITECTS

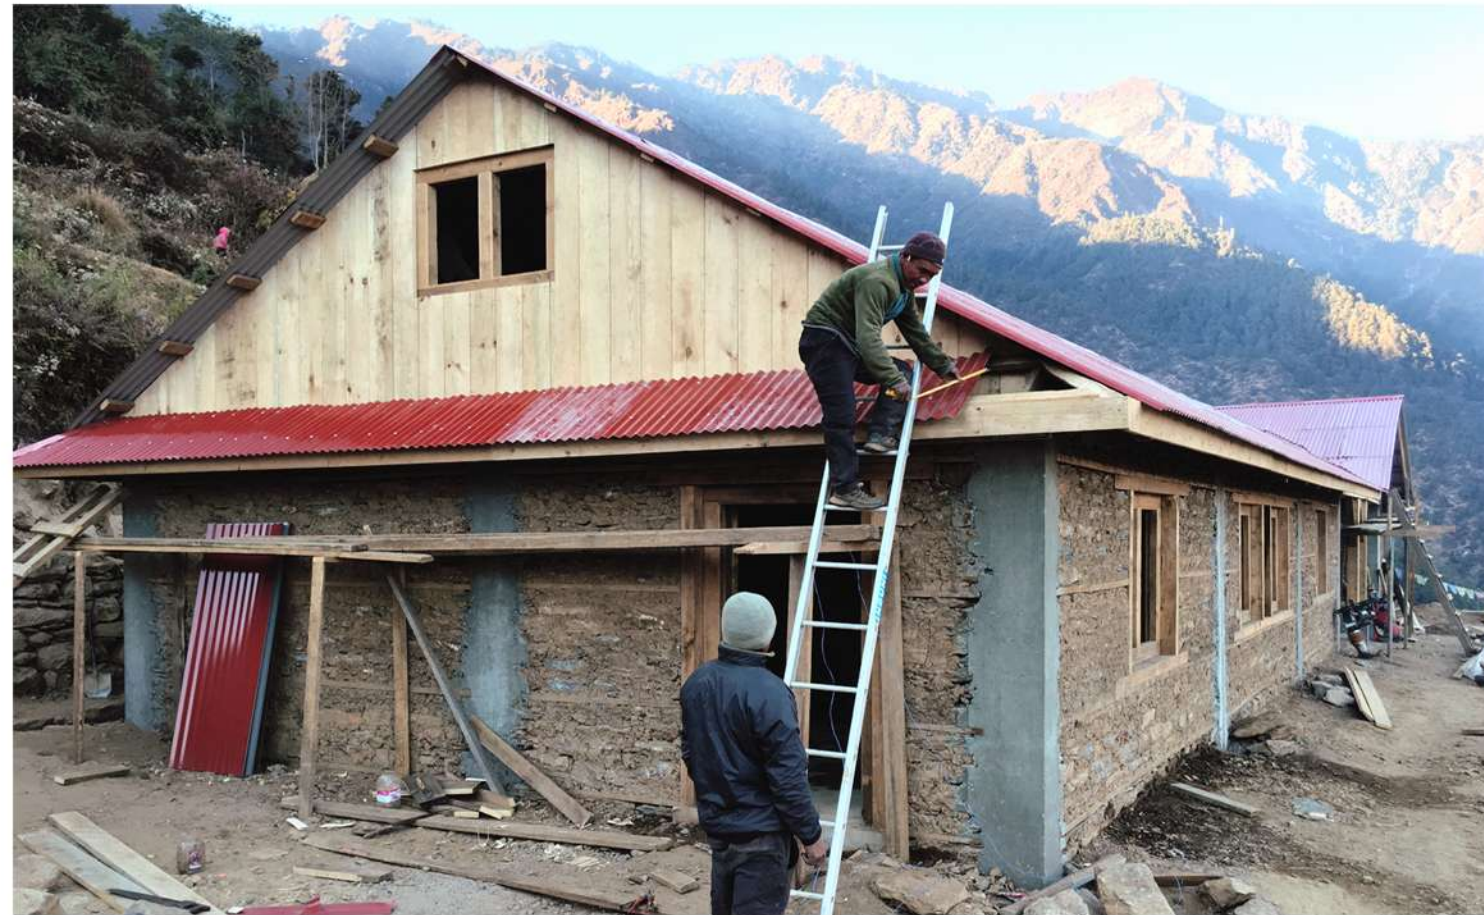
▲ Community center almost completed in December 2015.

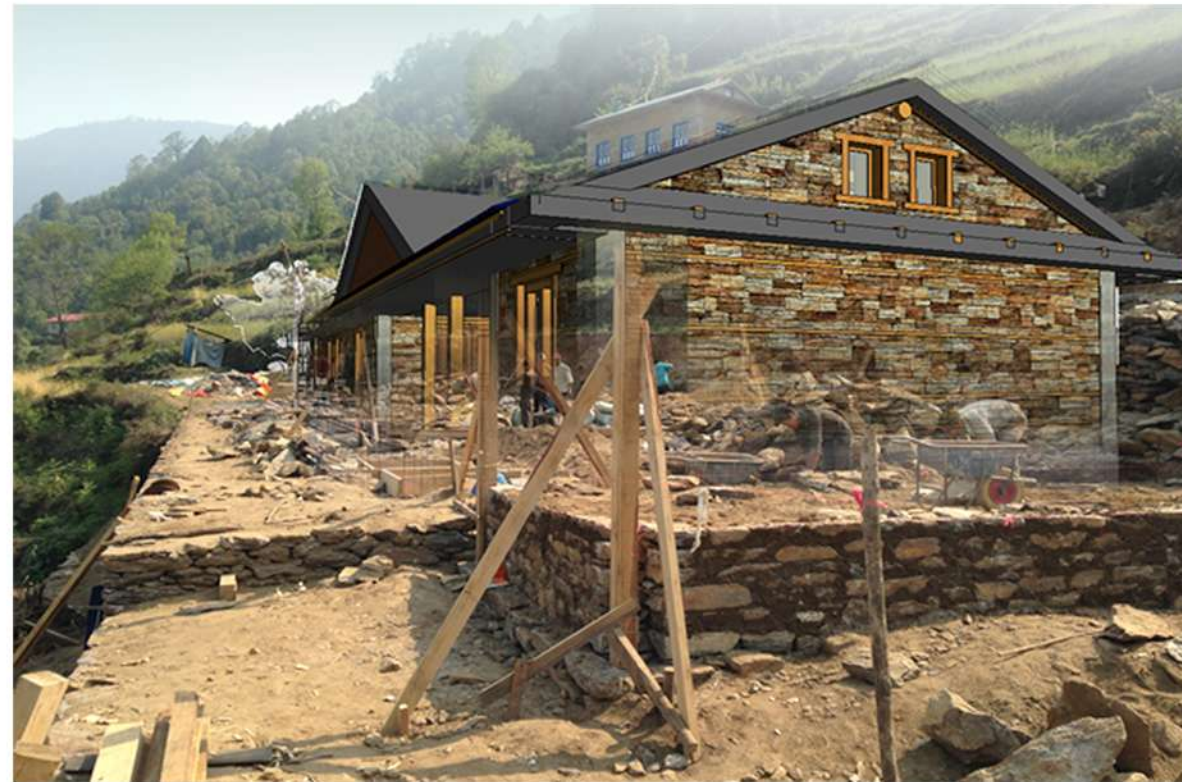
Rendering of the project during the finalization of the design performed alongside the construction. ▶

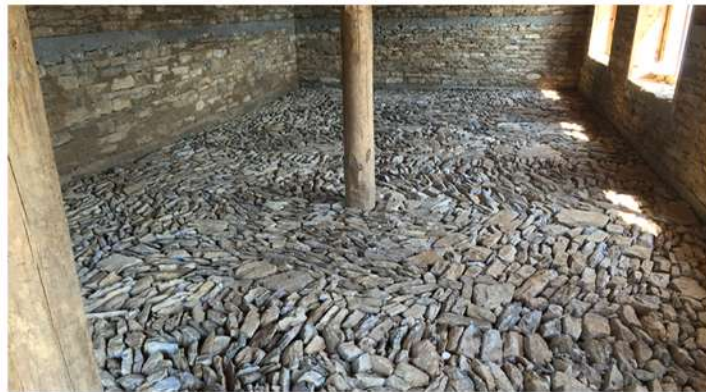
▲ Panoramic view of the construction site.

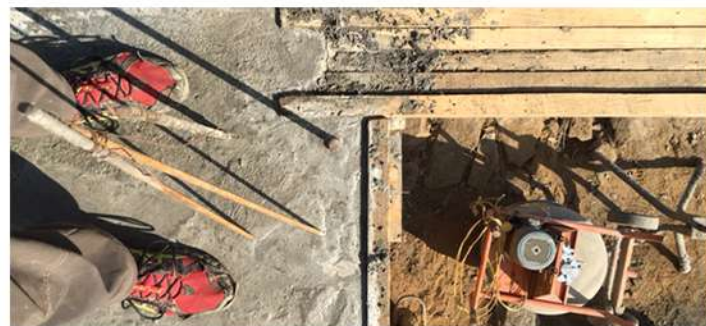
Building under construction. ▶
